Contract #: 04-0120F4Cty: SF/ALA Rte: 80 PM: 13.2/13.9File #: 69.28**WELDING INSPECTION REPORT****Resident Engineer:** Pursell, Gary**Address:** 333 Burma Road**City:** Oakland, CA 94607**Report No:** WIR-001035**Date Inspected:** 08-Dec-2007**Project Name:** SAS Superstructure**OSM Arrival Time:** 830**Prime Contractor:** American Bridge/Fluor Enterprises, a JV**OSM Departure Time:** 1730**Contractor:** Zhenhua Port Machinery Company, Ltd (ZPMC), Changxing Island **Location:** Shanghai, China**CWI Name:** Lee Chan Wu, Li Zhijiang**CWI Present:** Yes No**Inspected CWI report:** Yes No N/A**Rod Oven in Use:** Yes No N/A**Electrode to specification:** Yes No N/A**Weld Procedures Followed:** Yes No N/A**Qualified Welders:** Yes No N/A**Verified Joint Fit-up:** Yes No N/A**Approved Drawings:** Yes No N/A**Approved WPS:** Yes No N/A**Delayed / Cancelled:** Yes No N/A**Bridge No:** 34-0006**Component:** Tower Fabrication**Summary of Items Observed:**

Orthotropic Box Girder (OBG) and Tower Mock Up:

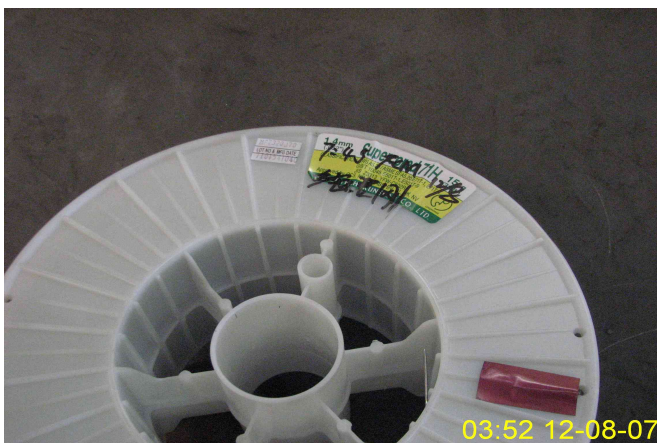
The QA Inspector observed two ZPMC welders using welding procedure specification WPS-B-T-2132-3 to make flux cored fillet welds on OBG plate 34A stiffener welds at the same time. ZPMC has multiple flux cored welding manipulators attached to a movable gantry that runs on a track along the length of the stiffener plates that are being welded. The QA Inspector observed a welding travel speed of approximately 450 mm per minute. As the welding commences, each of the welders is responsible for two of the flux cored welding heads. All welders are using spools of E71T-1 electrodes that have been marked as being installed earlier today. Welder Mr. Li Zhaogian completed weld SP063-01-041 with a welding current of approximately 300 amps and 27.5 volts and weld SP063-01-042 with a welding current of approximately 290 amps and 28.7 volts. Welder Mr. Xin Meng completed weld SP063-01-045 with a welding current of approximately 295 amps and 28.0 volts and weld SP063-01-046 with a welding current of approximately 300 amps and 28.9 volts. Following completion of the welding the QA Inspector observed QPMC QC CWI Inspector Mr. Li Zhijiang performing visual inspection of the completed welds. Mr. Li Zhijiang said he has marked several locations as needing to have weld repairs performed. See the photograph showing the spool of welding electrode which was used to make these welds. Items observed by the QA Inspector appear to comply with project specifications.
